Resolving a “Stickney Situation”

In 2019, the Sewer District completed a stream restoration project on Stickney Creek as part of its Regional Stormwater Management Program.

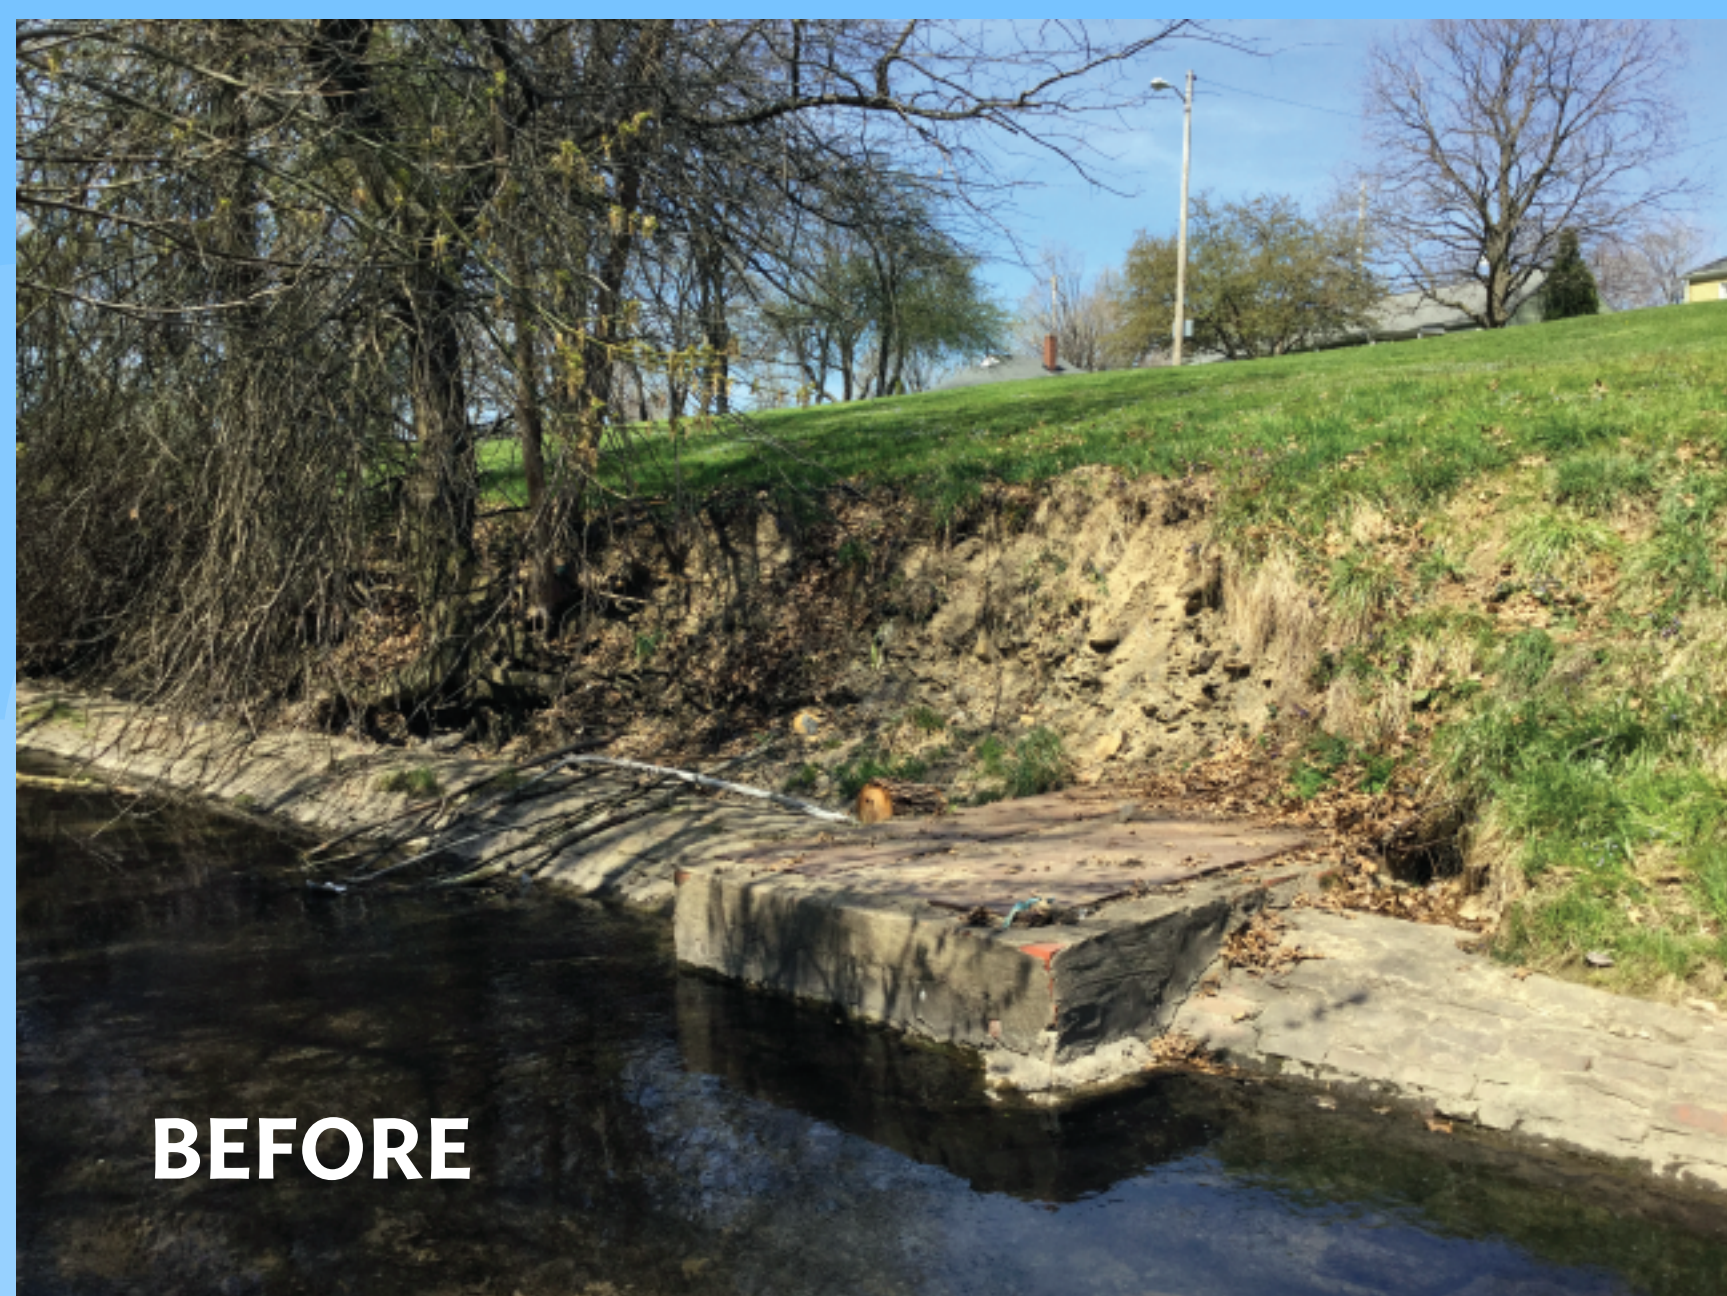
Without floodplain access, a stream will erode downward until it reaches harder material. When it can no longer erode downward, it begins to widen, eroding banks and threatening adjacent homes and utilities. The photo above shows the old sewer that was exposed by Stickney Creek on this site!

The Sewer District’s solution was to move the stream and the sewer away from one another and reconnect Stickney Creek to its floodplain.

This project relocated and increased the size of the 66” brick, combined sewer to 72”, to manage additional volume since its original construction. In summary, the project improved the alignment of the stream as it travels through the site and under Ridge Road, benefited water quality by reducing sewage contamination and erosion, and maintained fish and macroinvertebrate habitat in the stream.
